## Patheingyi - Myanmar Flood - 01/08/2015 Delineation Map - Monit02

Unusual heavy monsoon rains have been affecting Myanmar since 16 July causing river overflows and floods. In the past few days, torrential rains damaged farmland, roads, rail tracks, bridges and houses. Reservoirs are seasonal inundated areas and water bodies probably due to agricultural practices (paddy fields).  
 The core users of the map is Emergency Response Coordination Centre (ERCC).

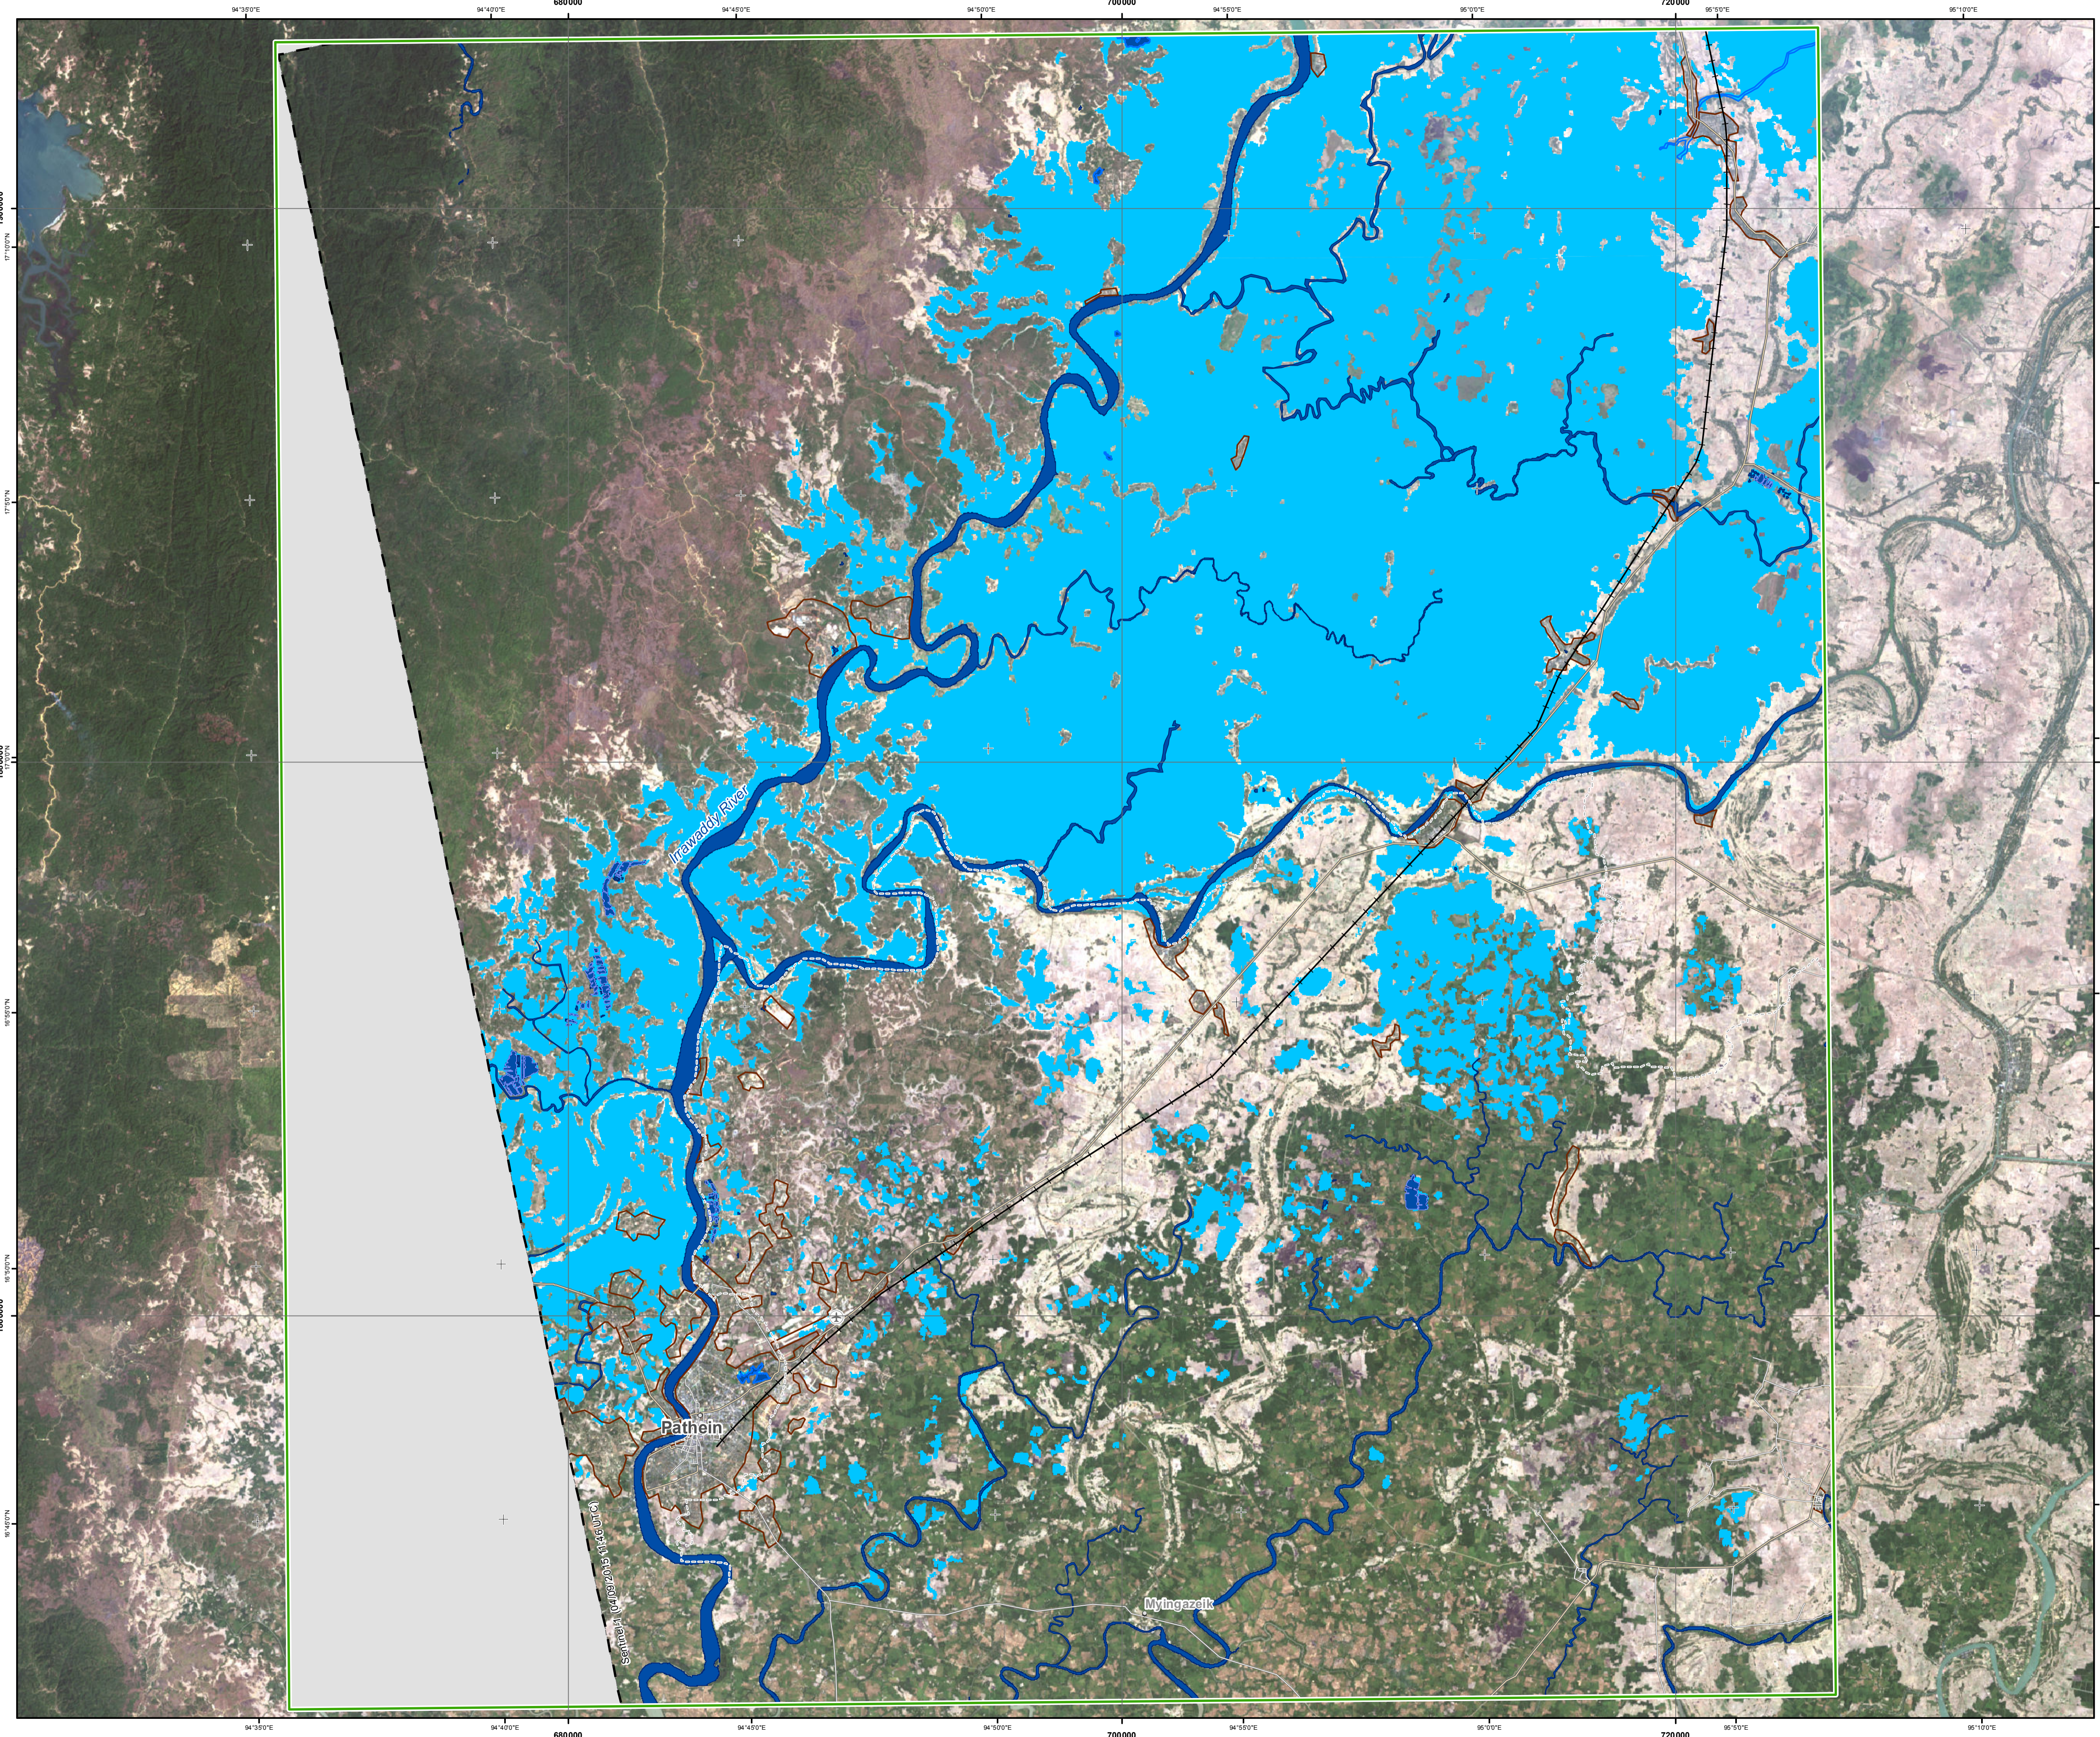
Consequences within the AOI on 04/09/2015			
		Affected	Total in
Flooded area	ha	1538	264219
Estimated population	Inhabitants	1538	869884
Settlements	Built-up area	ha	467
	No.	0	1
Transportation	Aerodrome	No.	0
	No.	0	7
	Railway	km	0
	Secondary road	km	14.4
	Local road	km	0
		km	309

The present map shows the flood delineation in the area of Patheingyi (MYANMAR). The basic topographic features are derived from public datasets, refined by means of visual interpretation of pre-event image Landsat-8.  
 Thematic layers, assessing the delineation of the event have been derived from post-event image Sentinel-1A.  
 All satellite images have been radiometrically enhanced, orthorectified with RPC approach (using SRTM elevation data).  
 The estimated geometric accuracy of this product is 50 m CE90 or better, from native positional accuracy of the background satellite image.  
 The estimated thematic accuracy of this product is 85 % or better, based on previous experience in using high-resolution SAR for flood extent delineation. Please be aware that the thematic accuracy might be lower in urban and forested areas due to known limitations of the analysis technique.  
 Only the area enclosed by the Area of Interest has been analyzed.
