# Pyinsalu - MYANMAR Flood - 01/08/2015 Delineation Map

**Map Information**  
 Unusual heavy monsoon rains have been affecting Myanmar since 16 July causing river overflows and floods. In the past few days, torrential rains damaged farmland, roads, rail tracks, bridges and houses. Reservoir are seasonal inundated areas and water bodies probably due to agricultural practices (paddy fields).  
 The core user of the map is Emergency Response Coordination Centre (ERCC).

**Map Production**  
 The present map shows the flood delineation in the area of Pyinsalu (MYANMAR). The basic topographic features are derived from public datasets, refined by means of visual interpretation of pre-event image Landsat-8.  
 Thematic layers, assessing the delineation of the event have been derived from post-event image Sentinel-1A.  
 All satellite images have been radiometrically enhanced, orthorectified with RPC approach (using SRTM elevation data).  
 The estimated geometric accuracy of this product is 40 m CE90 or better, from native positional accuracy of the background satellite image.  
 The estimated thematic accuracy of this product is 85 % or better, based on previous experience in using high

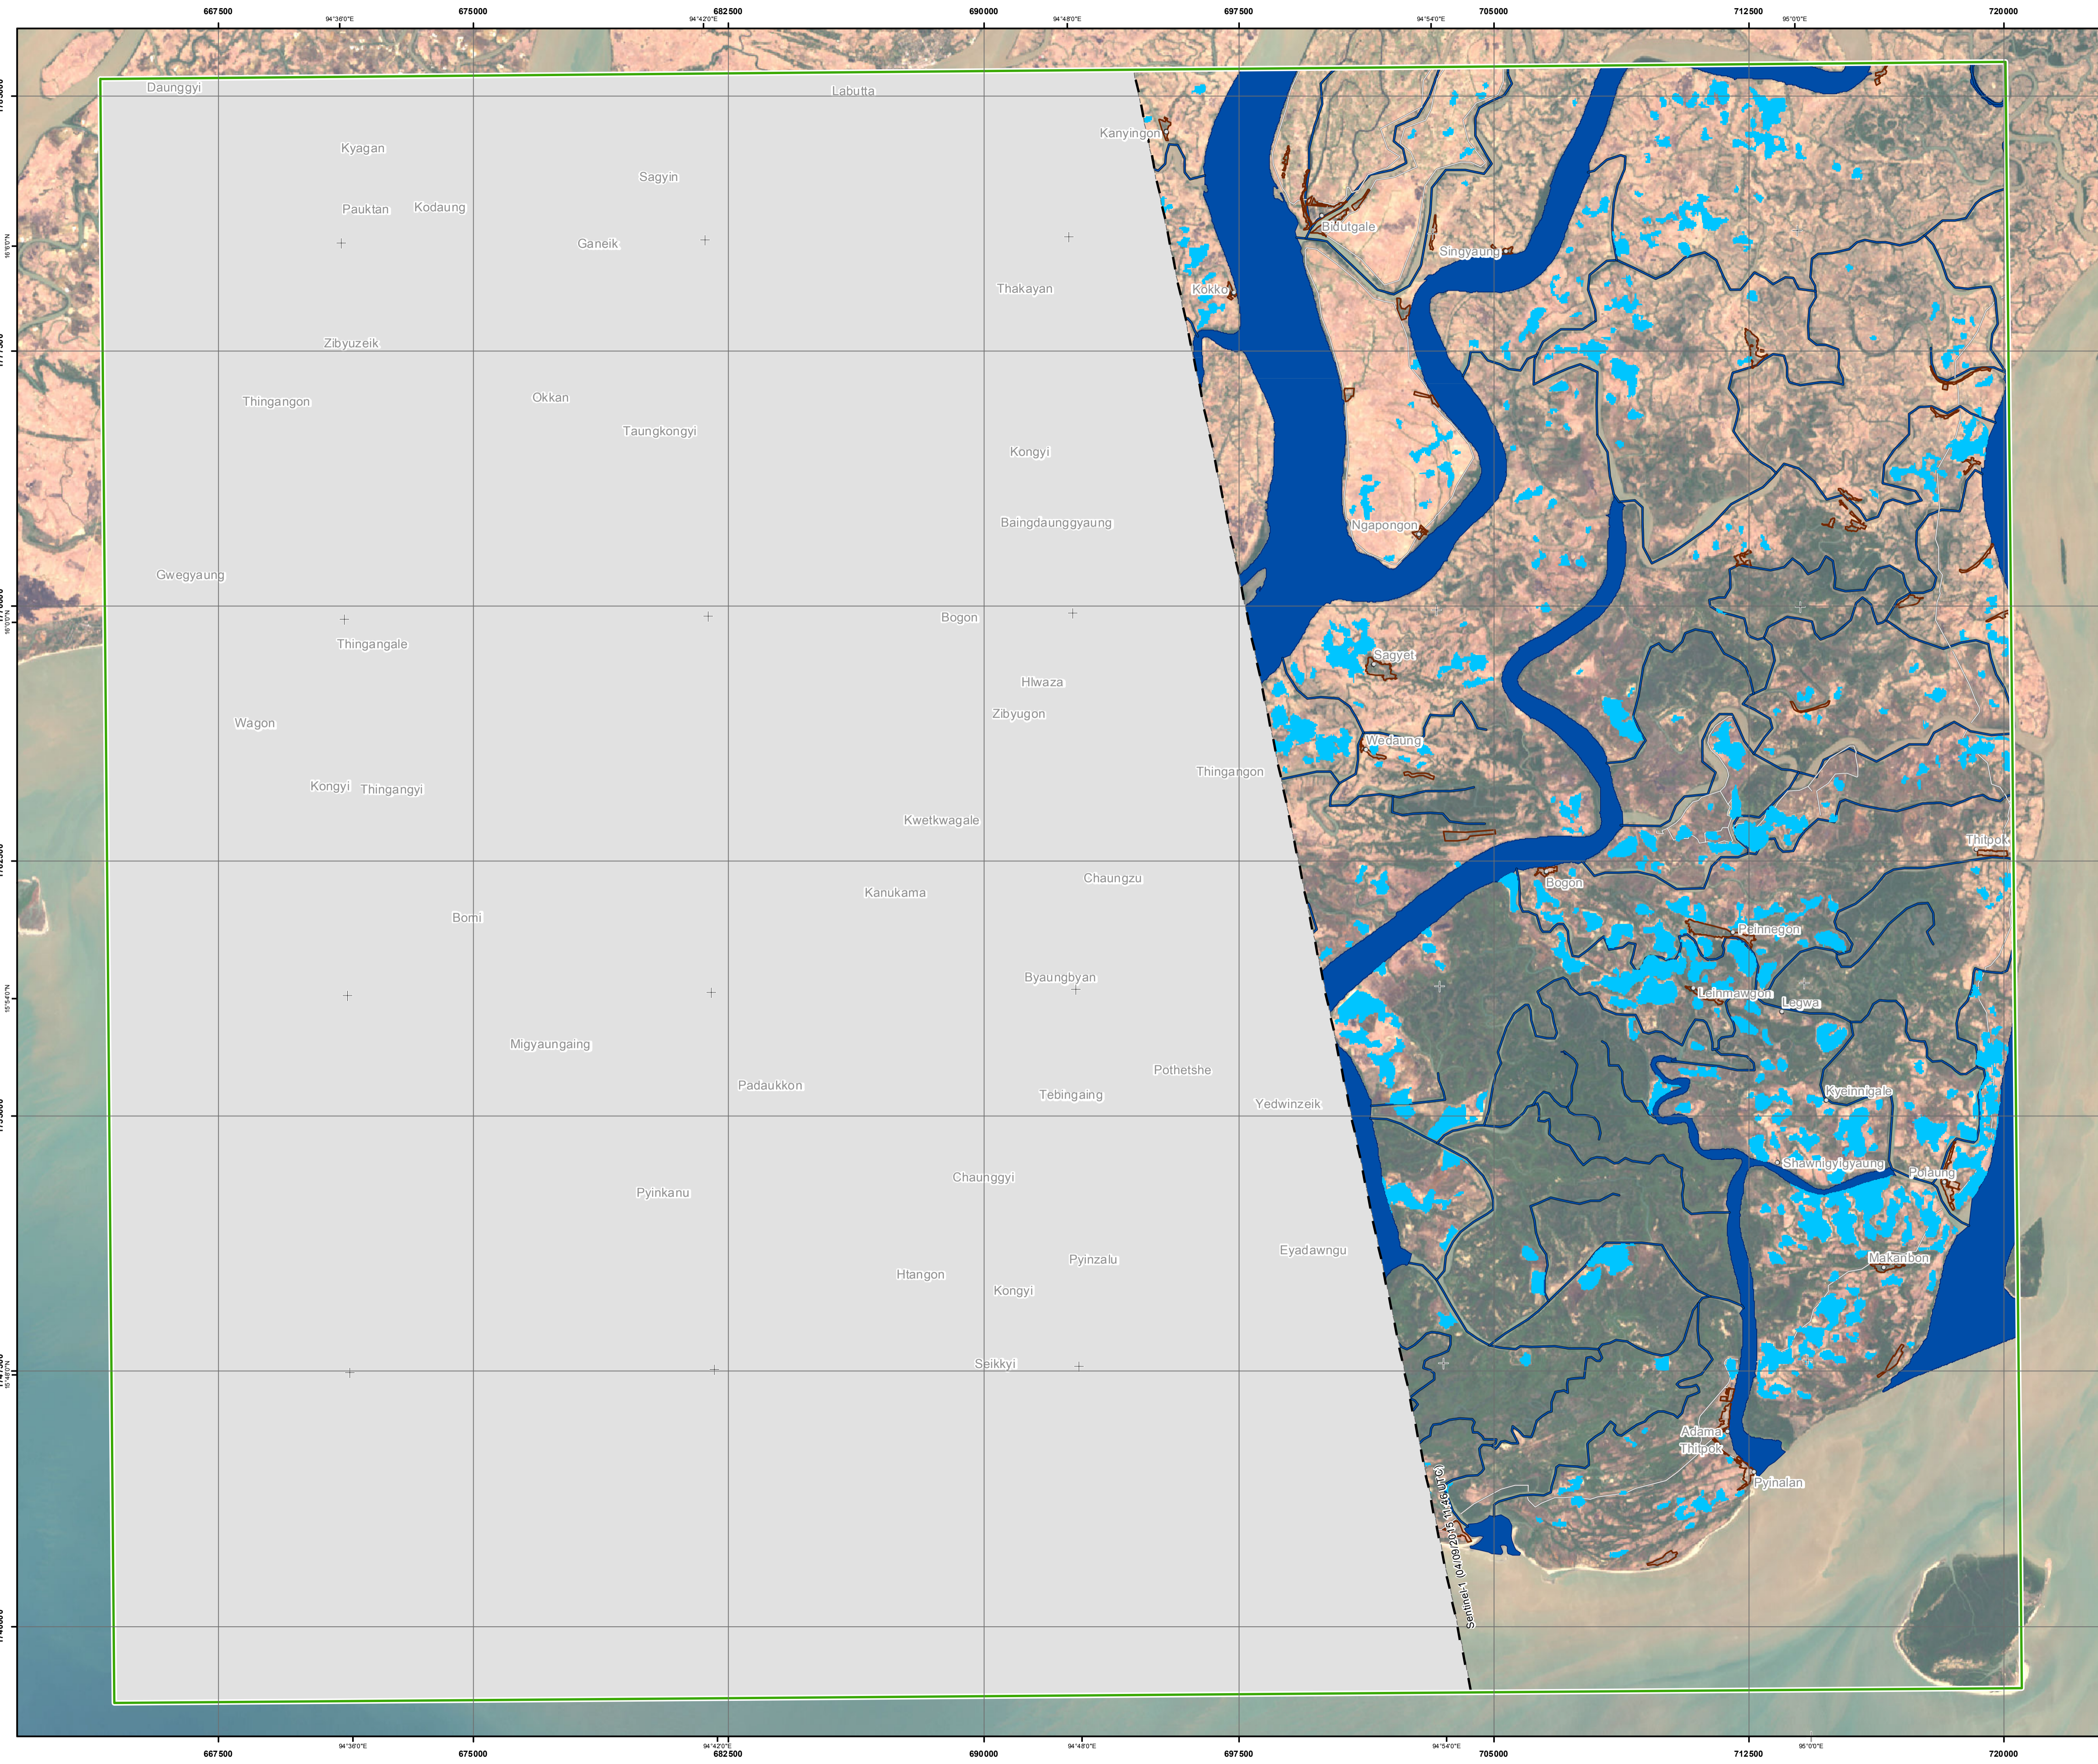
Only the area enclosed by the Area of Interest has been analyzed.

Affected	Total in
Flooded area	ha	5611
Estimated population	Inhabitants	9 137392
Settlements	Built-up area	ha 1 14875
Transportation	Local road	km 11.5 345
