Hinthada - Myanmar Flood - 01/08/2015 Delineation Map - Monit02

The present map shows the flood delineation in the area of Hinthada (MYANMAR). The basic topographic features are derived from public datasets, refined by means of visual interpretation of pre-event image Landsat-8. The thematic layer, assessing the delineation of the event, has been derived from post-event

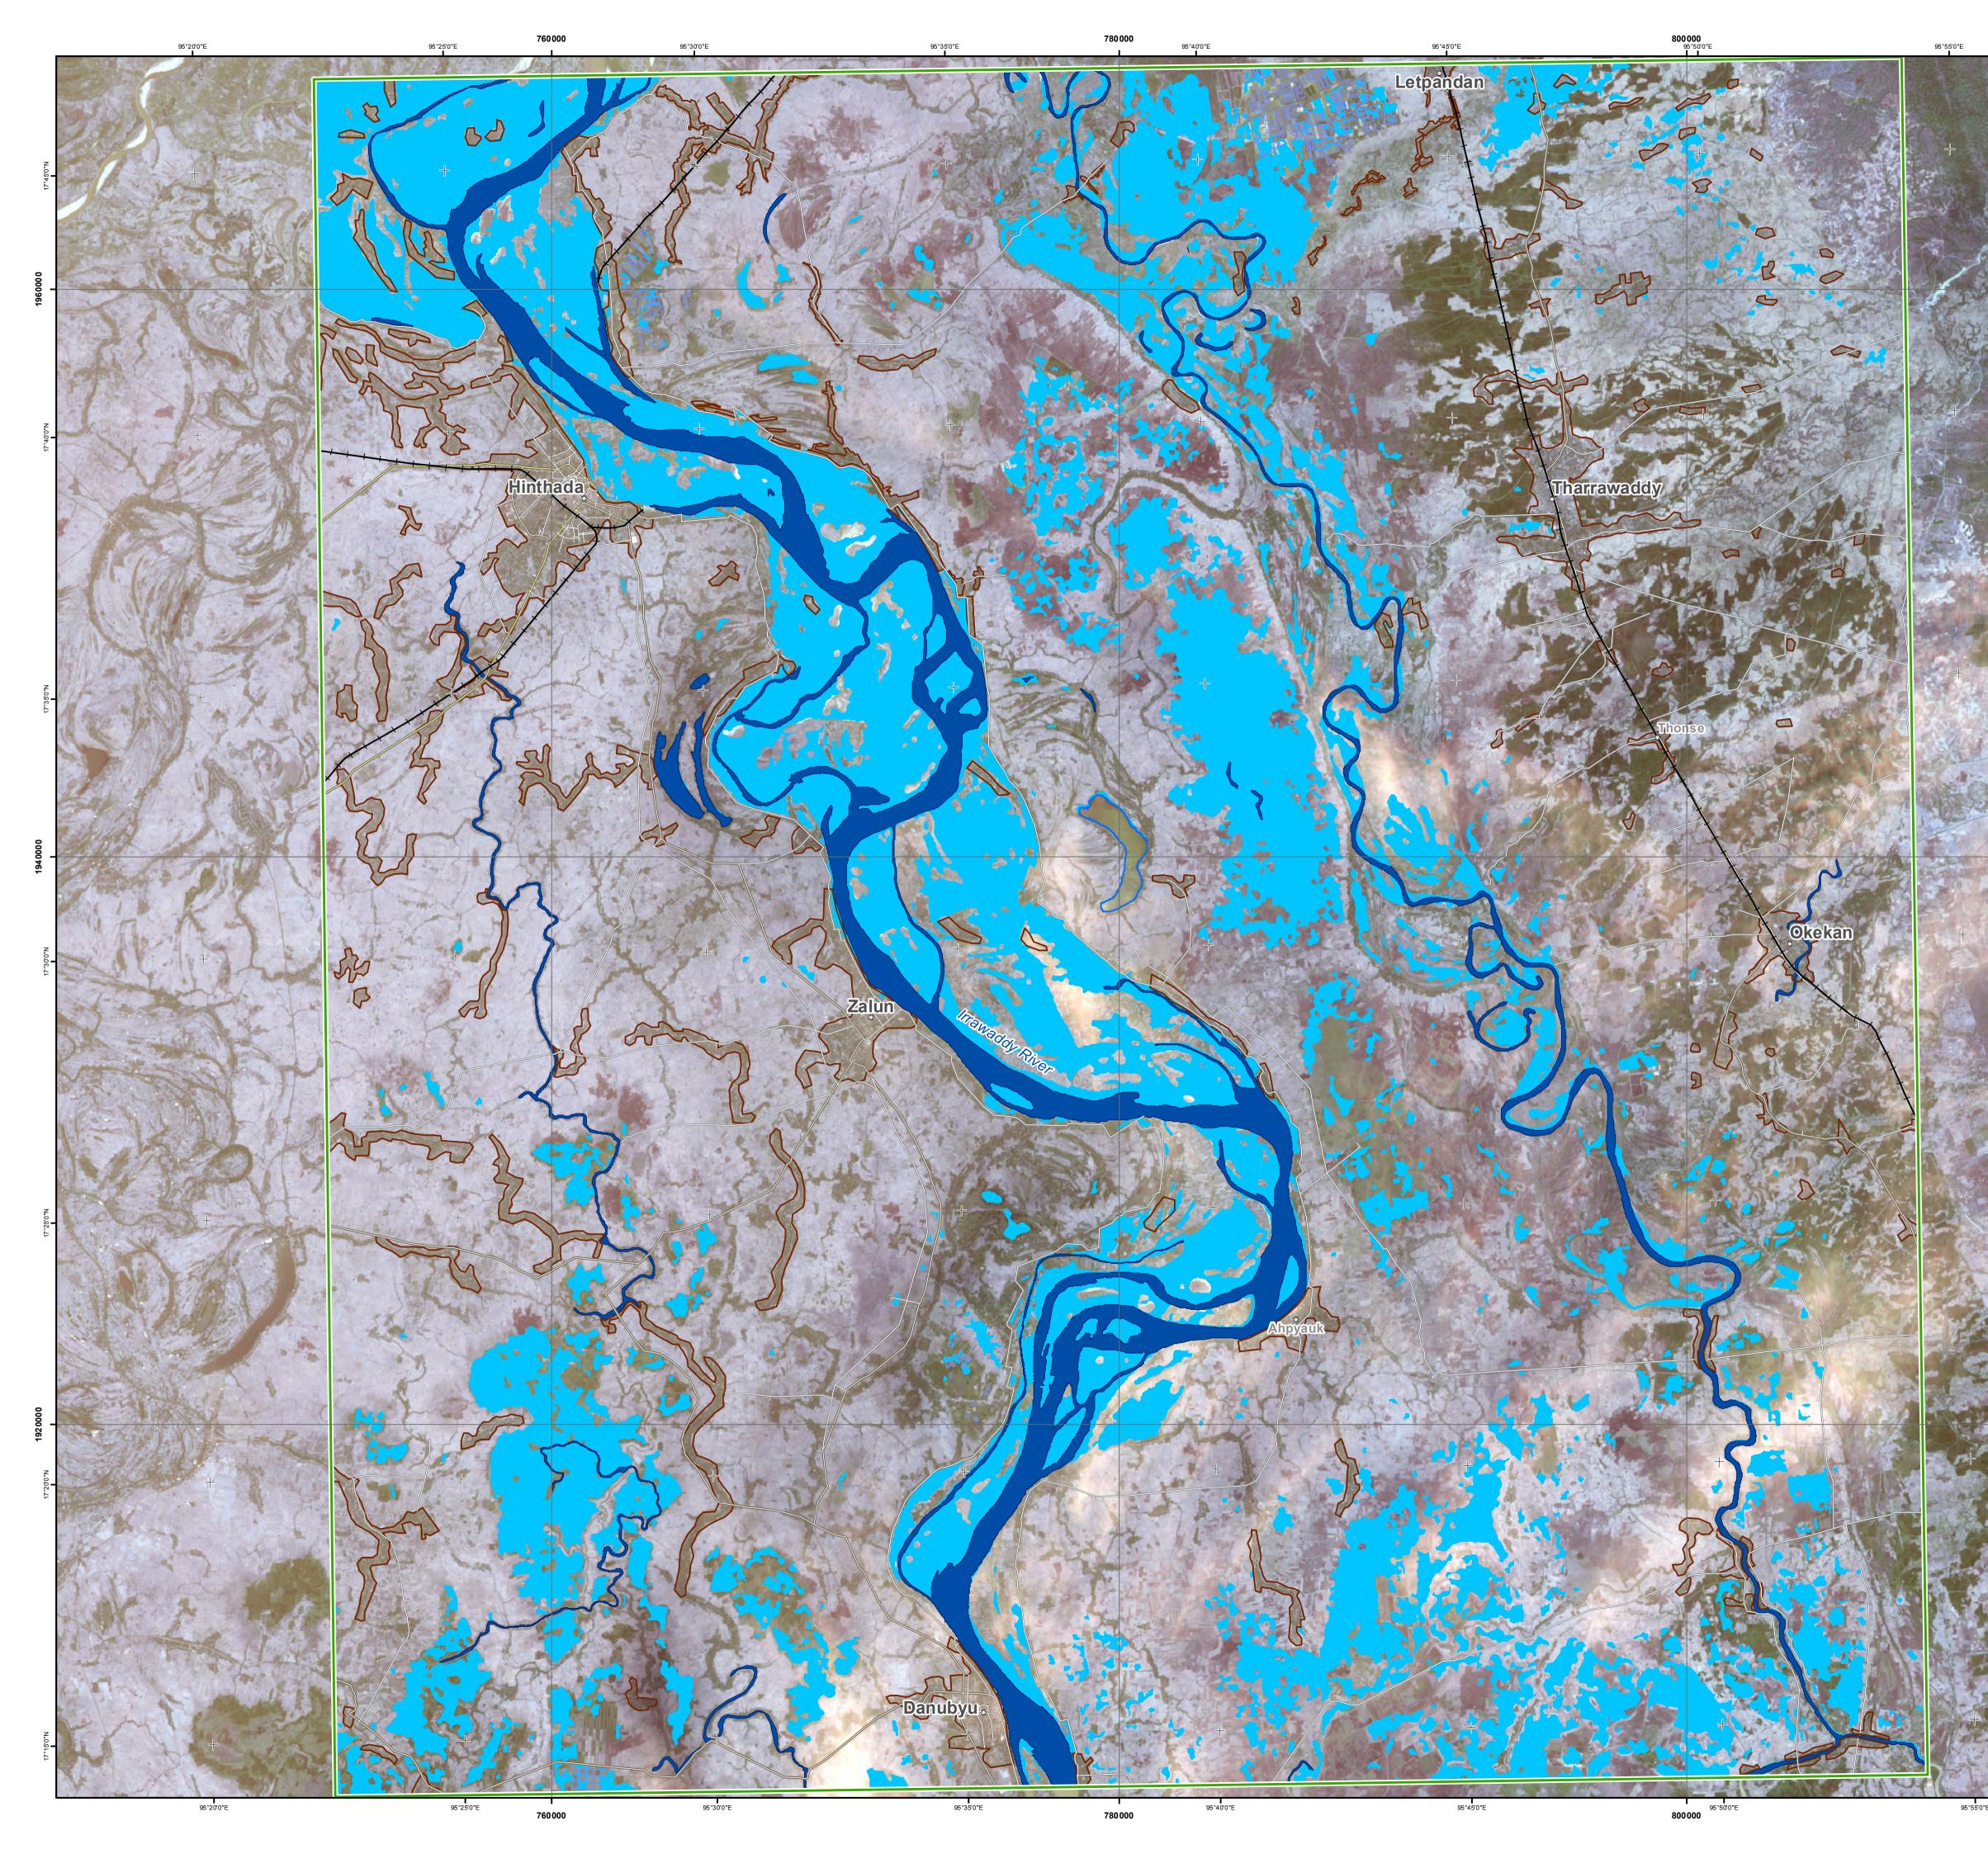
Affected	Total in AOI
Flooded area		ha 57169		
Estimated population		Inhabitants	102851	1156590
Settlements	Built-up area	ha	120	14875
Transportation	Railways	km	0	78
	Primary roads	km	0	25
	Secondary roads	km	1	174
	Local roads	km	13	600

image Radarsat-2. All satellite images have been radiometrically enhanced, orthocorrected with RPC approach (using SRTM elevation data). The estimated geometric accuracy of this product is 50 m CE90 or better, from native positional accuracy of the background satellite image.

The estimated thematic accuracy of this product is 85 % or better, based on previous experience in using high-resolution SAR for flood extent delineation. Please be aware that the the matic accuracy might be lower in urban and forested areas due to known limitations of the analysis technique.
