Kyauktan - Myanmar Flood - 01/08/2015 Delineation Map

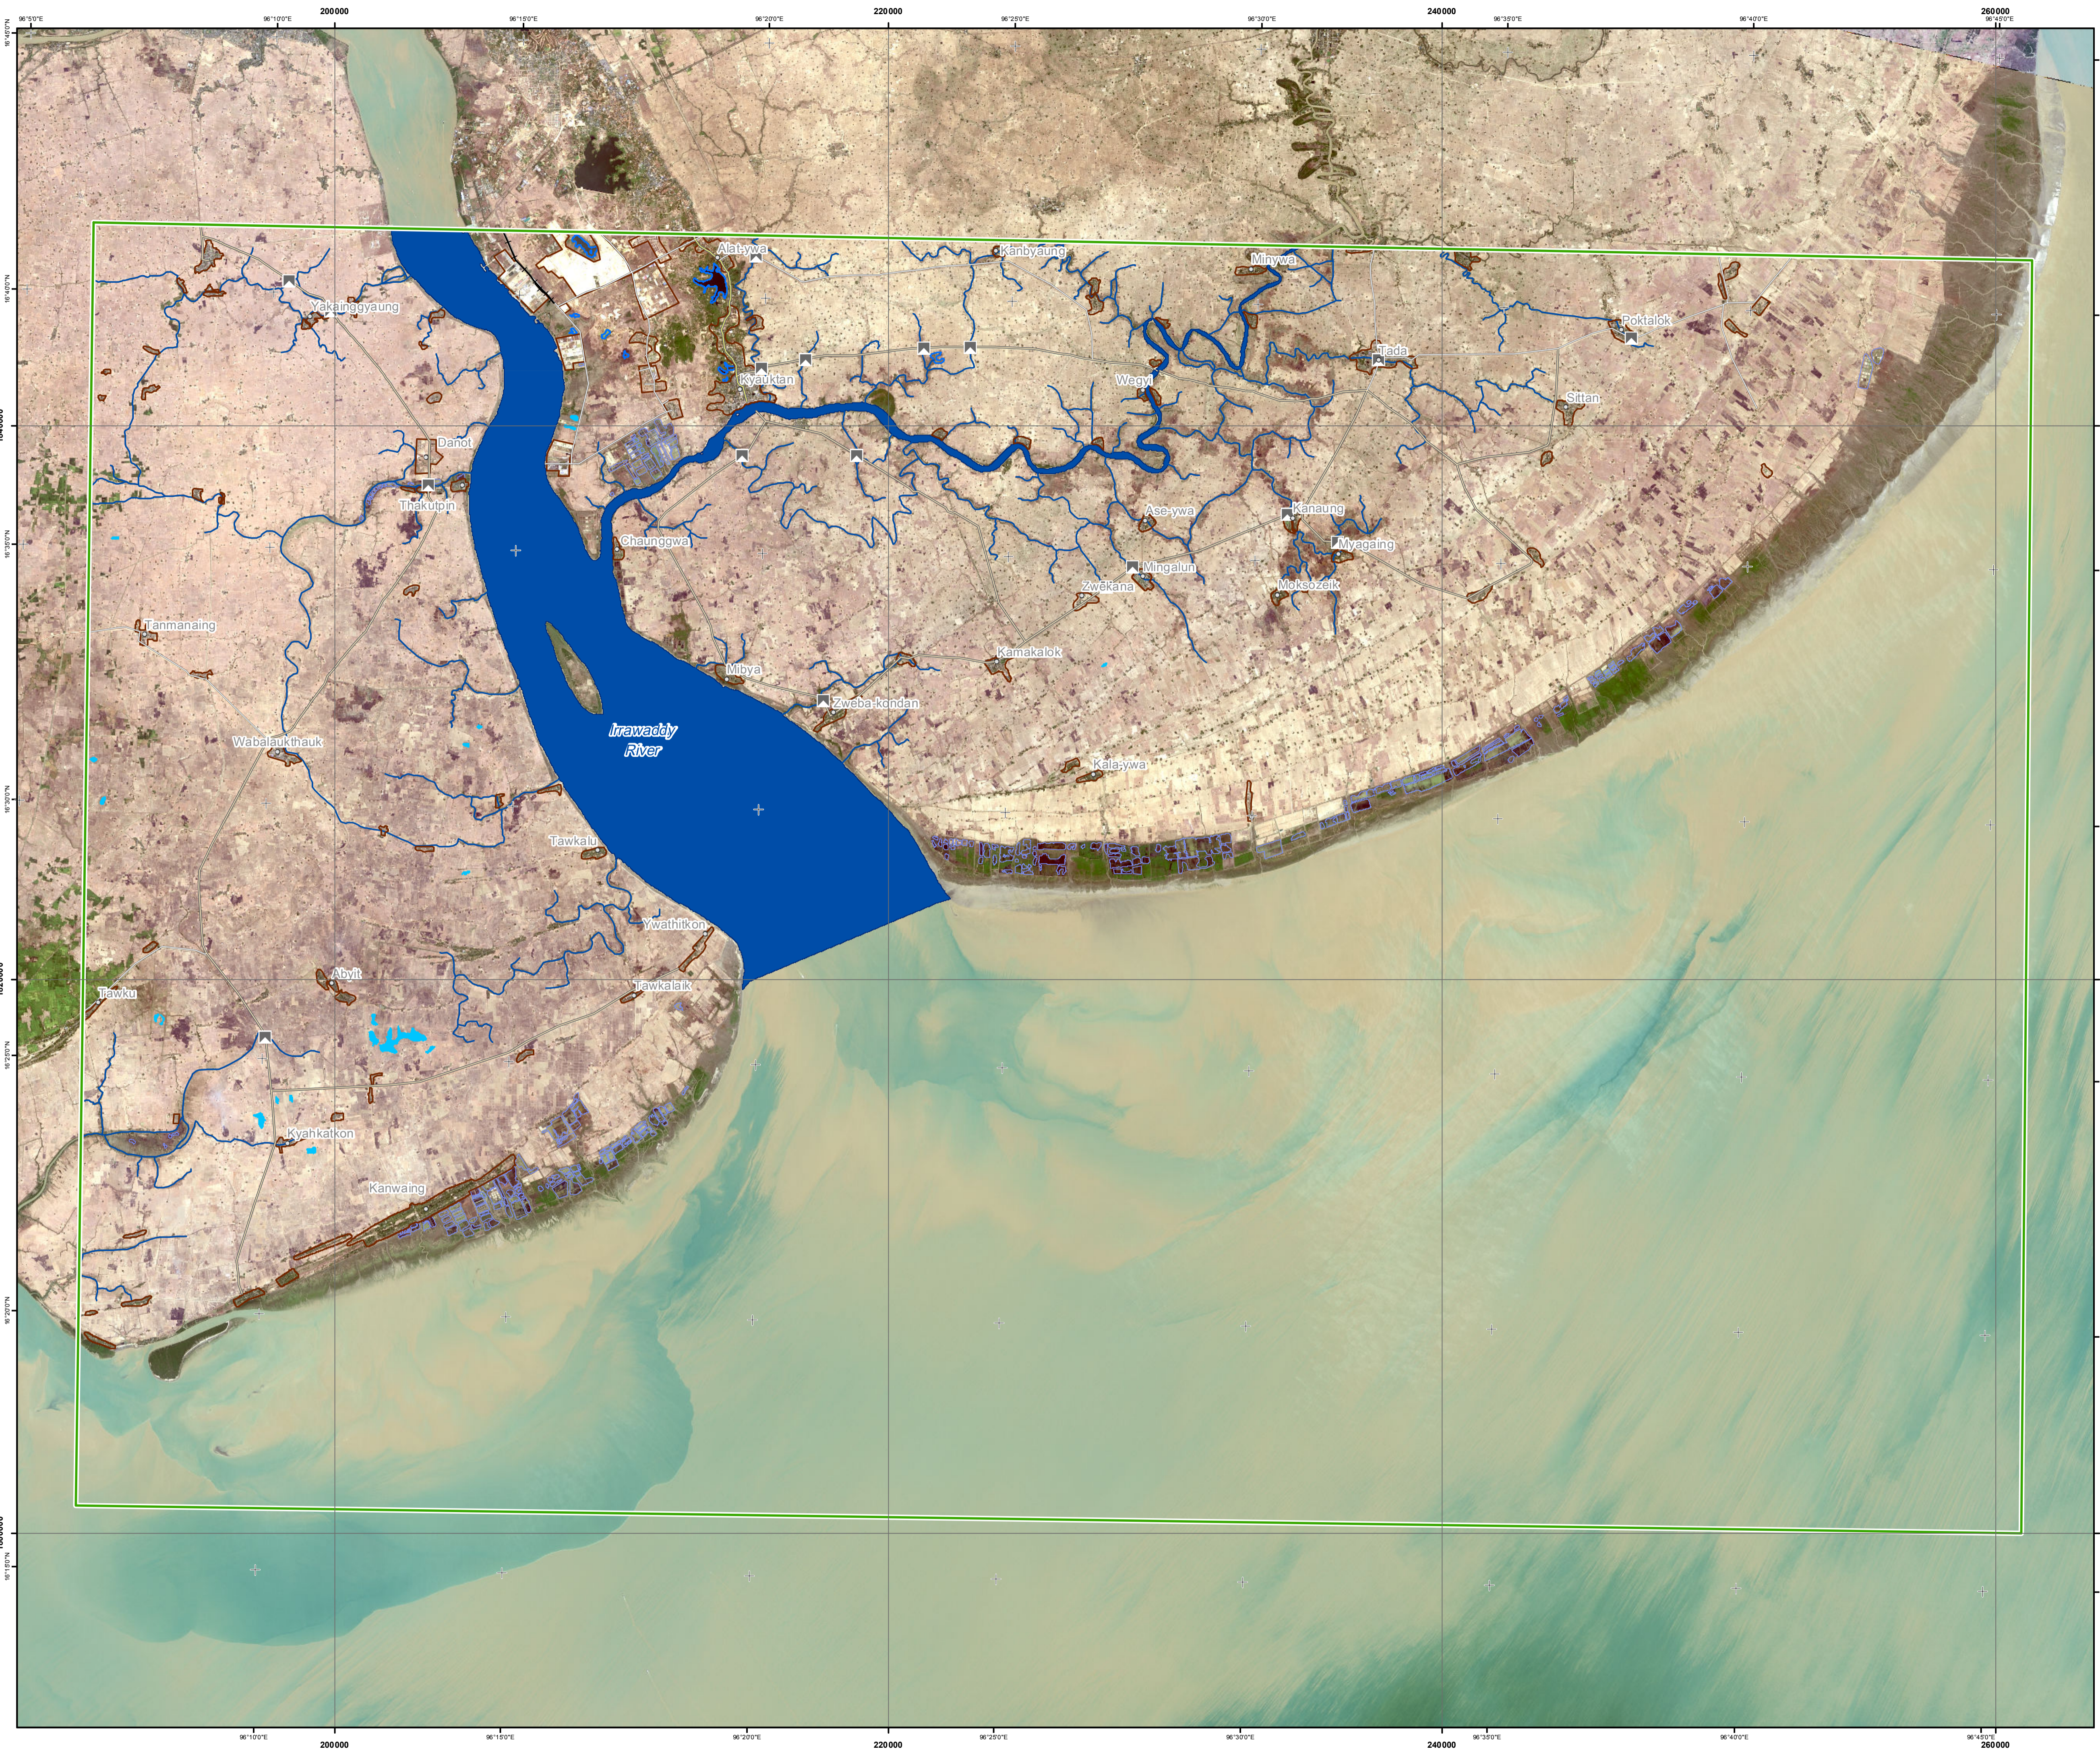
Affected		Total in AOI
	ha	Inhabitants	
Flooded area	156	457	308805
Estimated population			
Settlements	Built-up area	ha	3895
Transportation	Bridge	No.	18
	Primary road	km	7
	Secondary road	km	165
	Local road	km	86
	Railway	km	4

The present map shows the flood delineation in the area of Kyauktan (MYANMAR). The basic topographic features are derived from public datasets, refined by means of visual interpretation of pre-event image Landsat-8.
The thematic layer, assessing the delineation of the event, has been derived from post-event image Sentinel-1A.
All satellite images have been radiometrically enhanced, orthorectified with RPC approach (using SRTM elevation data).
The estimated geometric accuracy of this product is 40 m CE90 or better, from native positional accuracy of the background satellite image.
The estimated thematic accuracy of this product is 85 % or better, based on previous experience in using high-resolution SAR for flood extent delineation. Please be aware that the thematic accuracy might be lower in urban and forested areas due to known limitations of the analysis technique.
Only the area enclosed by the Area of Interest has been analyzed.

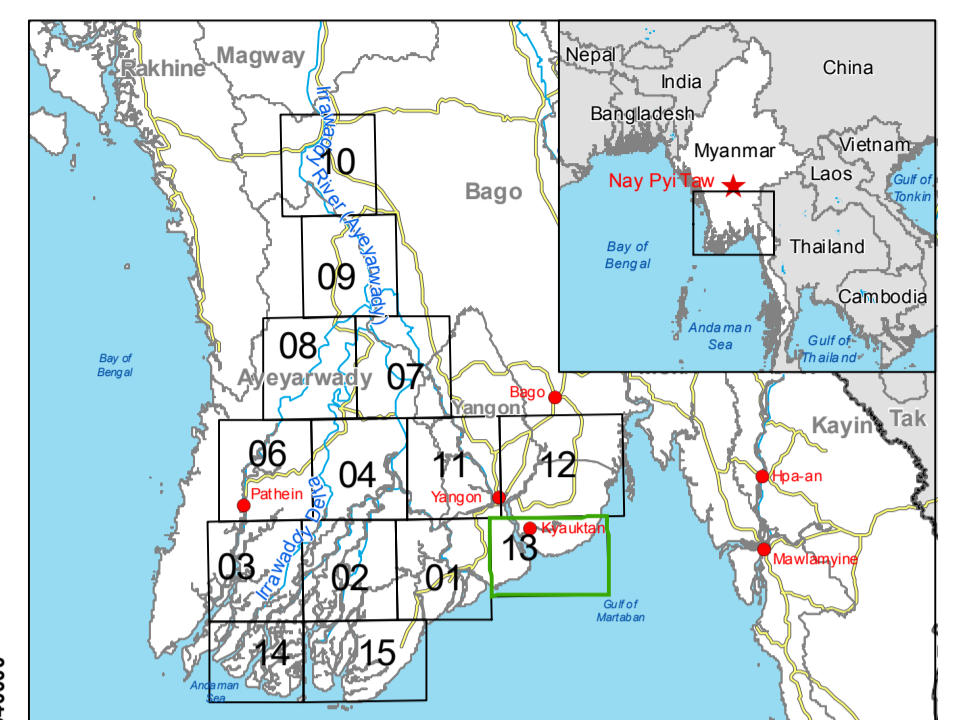
Consequences within the AOI on 04/09/2015
