DAMAGE ASSESSMENT IN RAKHINE STATE, MYANMAR

As Observed by Pleiades Satellite on May 18, 2023

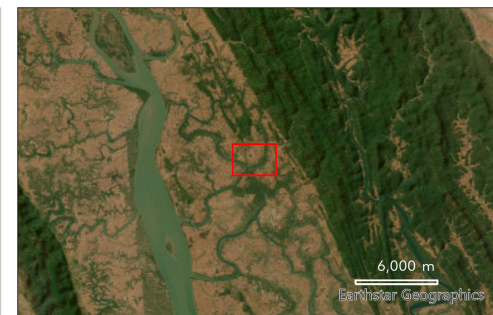
This map shows the detected damaged buildings in Bar Ta Lay (118 damaged buildings) and Lay Gwa Son (176 damaged buildings) Villages, Rathedaung Town, Sittwe Districts, Rakhine State, Myanmar on May 18, 2023, due to heavy rains and strong winds on May 14, 2023, from Cyclone Mocha.

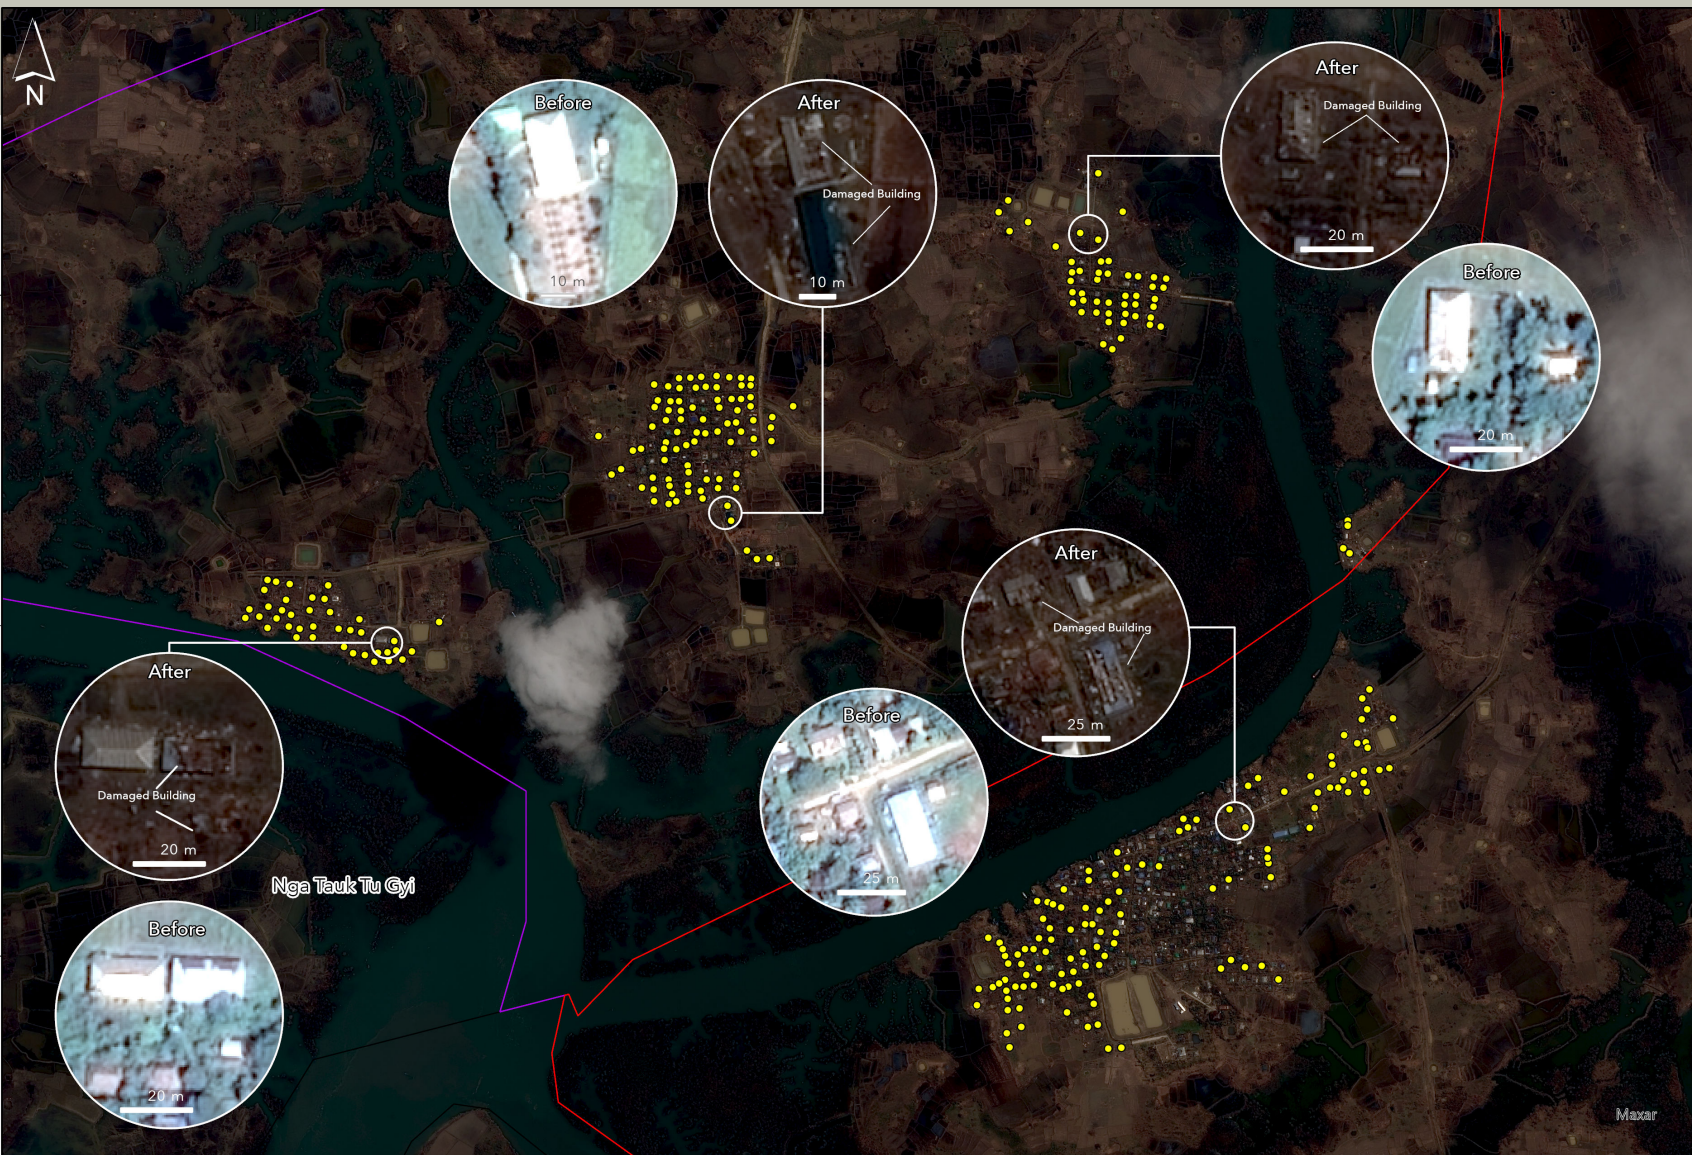
294

DAMAGED BUILDINGS
